Tuesday, March 29, 2022 Licence/Permit Number: 602642 **Date of Inspection:**

Licensee/Permittee Name: THE CORPORATION OF THE TOWNSHIP OF ZORRA

Site Name: ROBINSON PIT

Follow-up

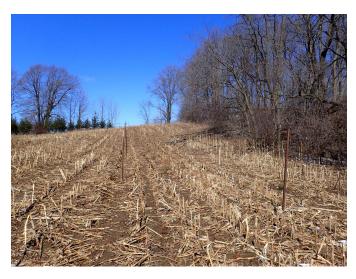
2022/03/29 13:09:53
TG-4 - P3290318.JPEG
Taken by: Stephen Douglas
View N along the ten metre setback to the W
of woodlot 1b. The setback is well-marked with
t--bar stakes

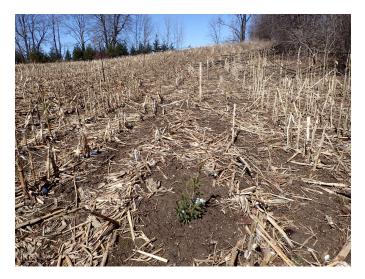
2022/03/29 13:10:11 TG-4 - P3290319.JPEG Taken by: Stephen Douglas Spruce tree in setback

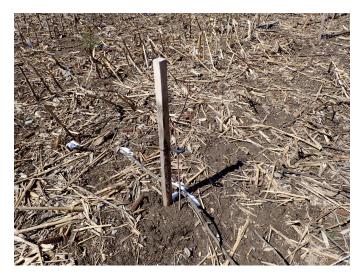
2022/03/29 13:10:33 TG-4 - P3290320.JPEG Taken by: Stephen Douglas Red Oak tree marked with 2-foot tall stake

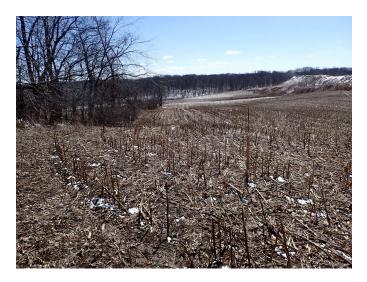
2022/03/29 13:12:33 TG-4 - P3290321.JPEG Taken by: Stephen Douglas View S along the ten metre setback to the W of woodlot 1b. Some tree plantings can be observed.
